DOT/FAA/CT-93/78
DOT-VNTSC-FAA-93-10

FAA Technical Center
Atlantic City International Airport,
N.J. 08405

Full-Scale Testing and Analysis of Curved Aircraft Fuselage Panels

Final Report

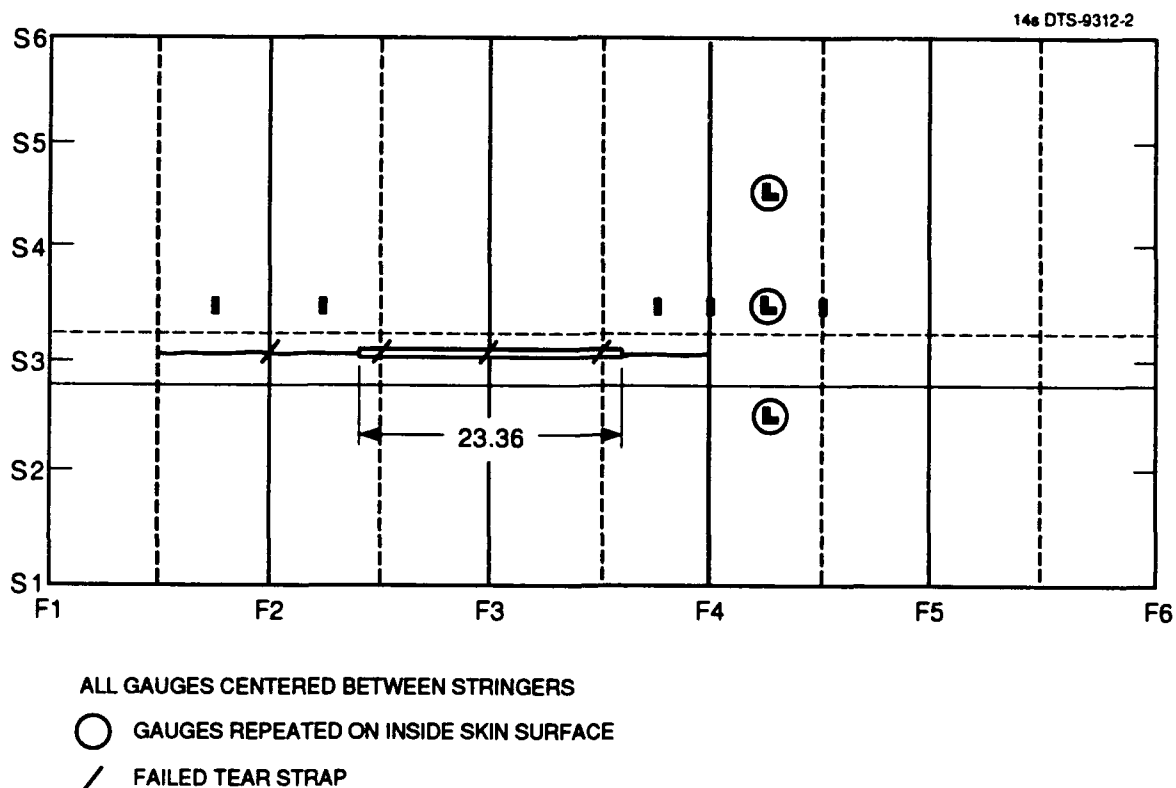
Figure 9. Panel 8 - After Fracture

For the failure tests of Panels 8 and 9, the internal panel pressure was increased at a constant rate of 1 psi per second. Stable crack growth began in Panel No. 8 at approximately 7 psi. The total crack extension reached 0.1 in. at 8.6 psi. The center tear strap at F3 failed at 9.4 psi. From review of the videotape, (referring to the F3 tear strap failure as time zero) the tear strap between F2 and F3 failed at 0.37 sec and the tear strap between F3 and F4 failed at 0.40 sec. The tear strap at F2 then failed at 0.70 sec and pressurization could not be maintained. The final crack is shown in Figure 9. A photograph of the failed panel is shown in Figure 10.

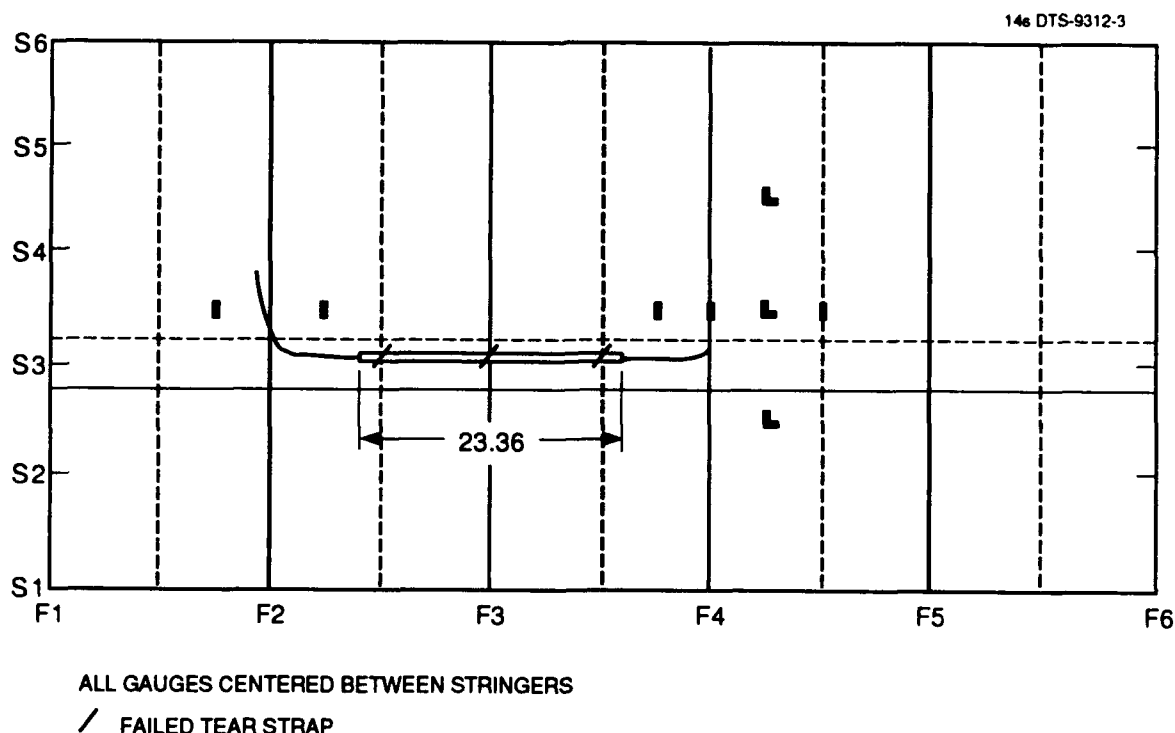
Figure 11. Panel 9 After Fracture

Stable crack growth began in Panel No. 9 at approximately 6.2 psi. The total crack extension reached 0.1 in. at 7.5 psi. The center tear strap at F3 and the midframe bay tear straps on either side of F3 all failed at 10.5 psi. From the crack

propagation gauges and the close-up videotape, it is evident that the first ligaments past the lead crack tips failed completely approximately 2 sec prior to the tear strap failures. Further from the videotape, the crack turns at F2, resulting in a flapping failure, 0.27 sec after failure of the tear straps. The final crack is shown in Figure 11. A photograph of the failed panel is shown in Figure 12.

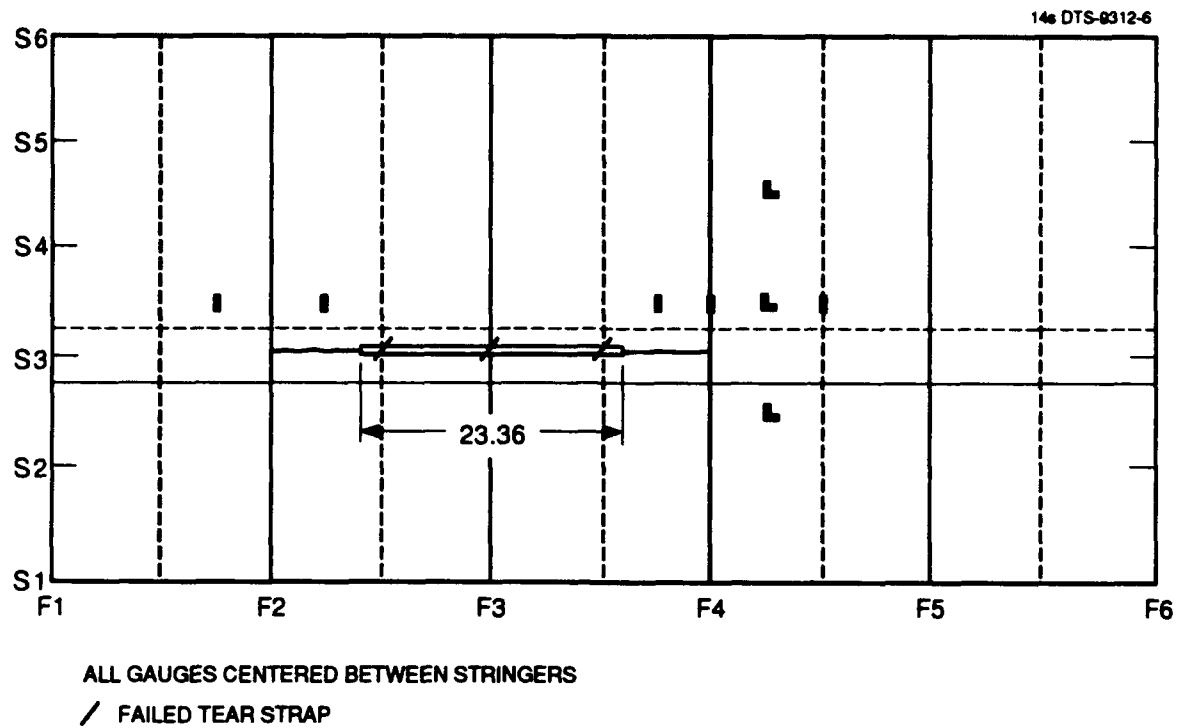
Figure 13a. Panel 16 - After Fracture

For the failure test of Panel No. 16, the incremental loading procedure, discussed in subsection 5.2, was used. Due to "Krack Gage" bonding problems, stable crack growth was not recorded. Failure of the three center tear straps occurred at 9.6 psi. The crack grew in both directions to the next frame. The final crack is shown in Figure 13a. A photograph of the failed panel is shown in Figure 13b.

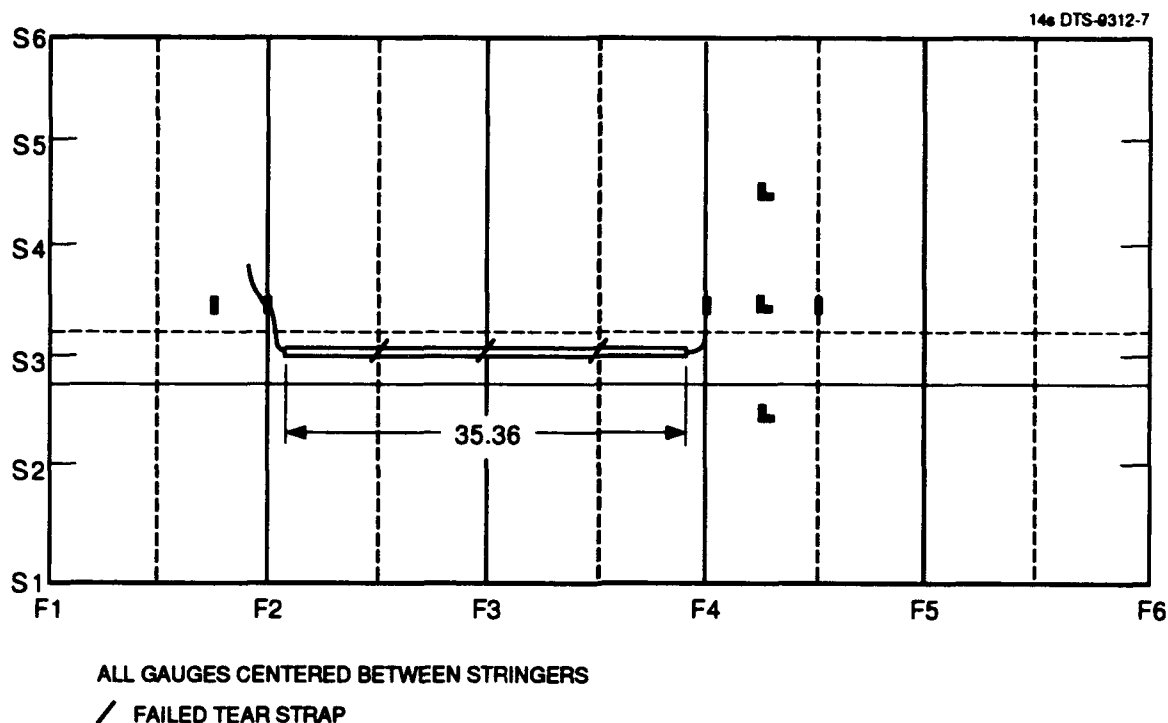
Figure 18. Panel 14 - After Fracture

frame and then turned approximately 1 in. away from the lap splice. From review of the videotape, the turned crack at F2 continued to grow after 1.1 sec and progressed to 7.5 in. away from the lap splice. The tear strap at F2 did not fail. The final crack is shown in Figure 18. A photograph of the failed panel is shown in Figure 19.

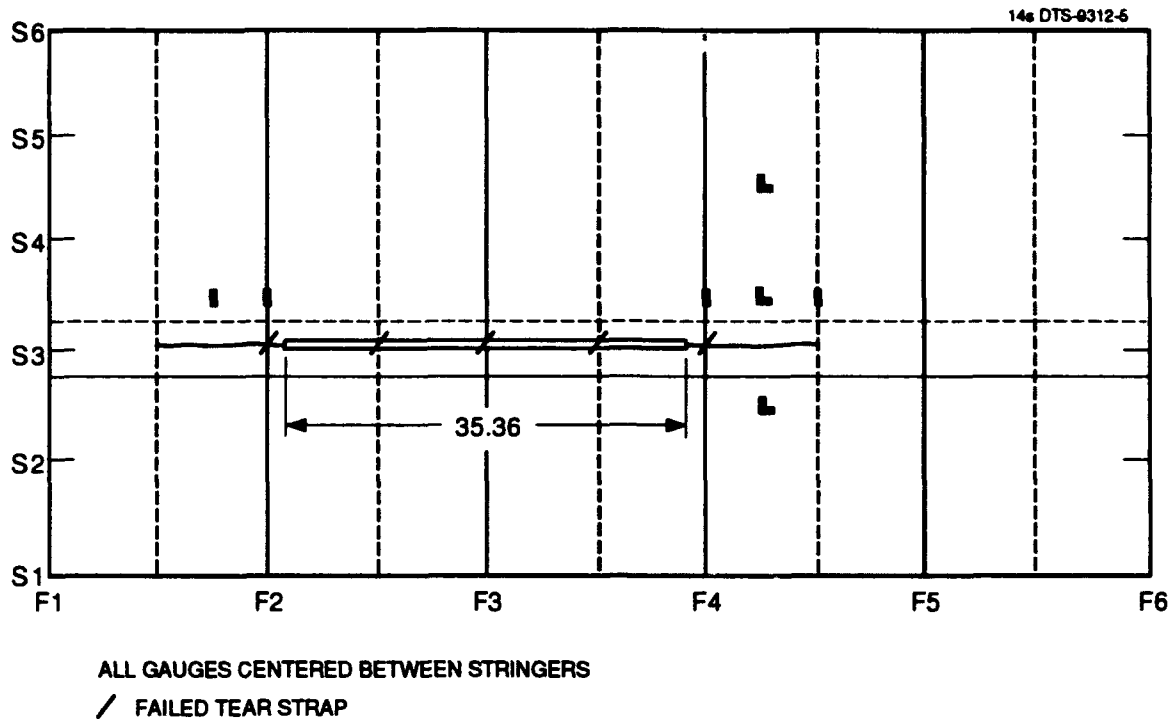
Figure 20. Panel 15 - After Fracture

Stable crack growth was observed in Panel No. 15 at approximately 3.5 psi. The total crack extension reached 0.1 in. at 5.9 psi. Stable crack growth resulted in the failure of the first ligament nearer F4 at 7.2 psi. Further incremental pressure increases were applied and failure of the first ligament nearer F2 was recorded at 7.8 psi. The center three tear straps also failed at this time and the crack grew in both directions to the next frame. The tear strap at F2 failed 0.7 sec later and that crack tip began to grow toward the next tear strap. At 0.9 sec after initial failure, the crack had propagated to the tear strap between F4 and F5. At this same time, the tear strap at F2 failed, the crack grew immediately to the next tear strap, and pressure could not be maintained. The final crack is shown in Figure 20. A photograph of the failed panel is shown in Figure 21.

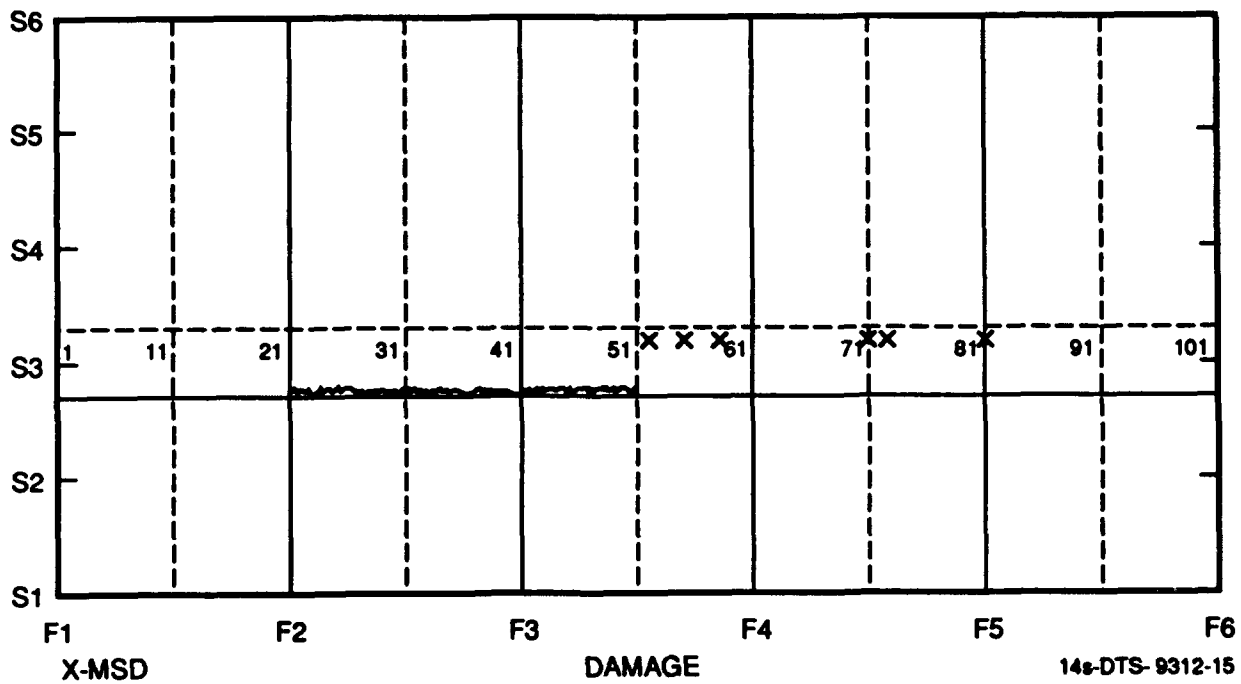
Figure 38. Test Panel No. 12 After Fracture

visible along the upper rivet row. At 114,571 cycles, lap joint leakage became pronounced. Upon inspection, link-up had occurred between rivets 35-37 on the lower rivet row. The panel fractured at 115,755 cycles. The failure occurred from rivets 22 through 51 on the lower rivet row, which ruptured the lower skin, as shown in Figures 38 through 40. No tear straps were broken.
